NASA Engineering and Safety Center Technical Consultation Report	Document #: RP-05-122	Version: 1.0
Title: NESC Independent Review of the Mars Reconnaissance Orbiter (MRO) Contamination Thermal/Vacuum (T/V) Anomaly Technical Consultation Report		Page #: 1 of 56

**NESC Independent Review of the
Mars Reconnaissance Orbiter (MRO) Contamination
Thermal/Vacuum (T/V) Anomaly Technical Consultation Report**

August 18, 2005

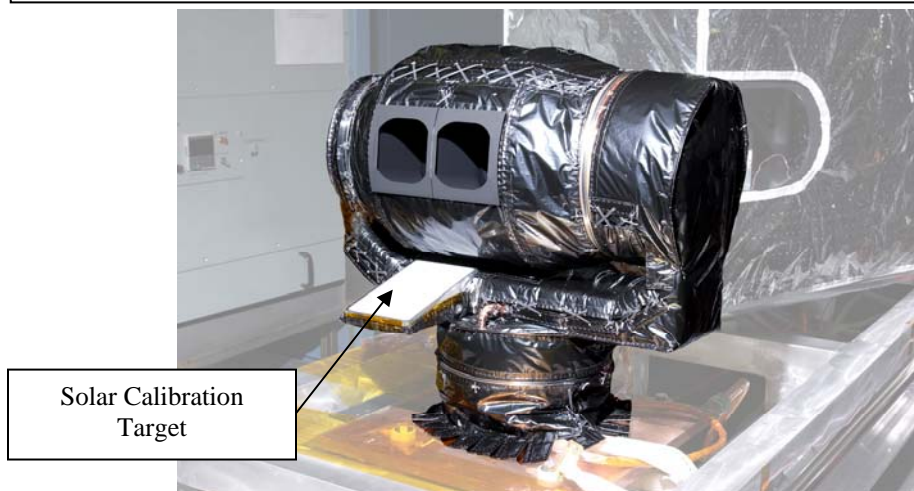
The Mars Climate Sounder (MCS) Instrument

R2- It is up to the MCS team to assess the trade-offs and to decide to clean or not. Effort should be made to recover calibration as much as possible from observations of the moon (during early cruise) and Mars (during cruise and orbital phases). This will impact cruise and orbital operations. It will require a significant and on-going effort to quantify calibration uncertainties.

- 1) Cleaning the target with the developed acetone-brushing technique. Further analysis by the MCS Team must:
 - Demonstrate that the acetone-brushing will not alter the SCT surface properties or introduce contamination.
 - This is being tested using a recently discovered off-cut of the flight SCT plate which will be cleaned and then visually inspected and characterized using an UV-Laser Induced Native Fluorescence (UV- LINF) technique
 - Validate that the visually observed brightening of the cleaned test area on the SCT is sufficient evidence that enough contamination is on the target to warrant cleaning, given the risk of altering the surface
